Permanent Building Committee Killam School Building Committee

Date: 2024-03-25 Time: 7:00 PM

EXISTING CONDITIONS ASSESSMENT DISCIPLINES

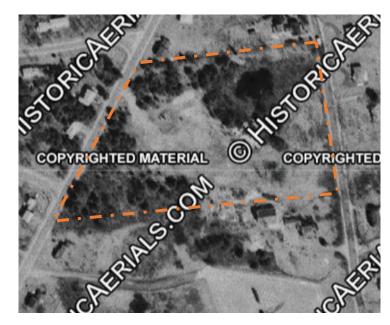
1965 Aerial image of the Killam site

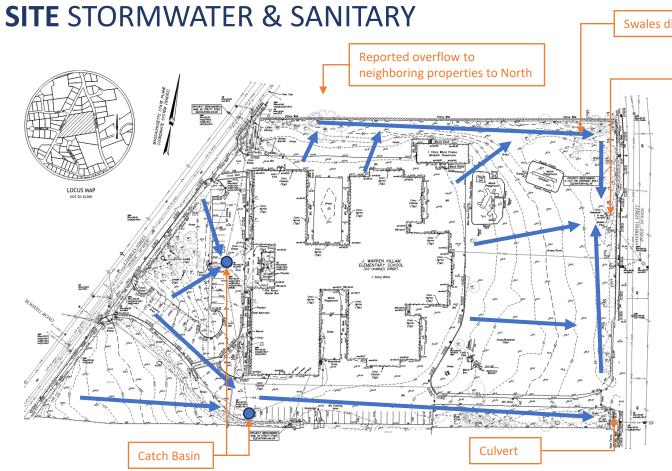
Swales direct water to low point.

Crushed pipe is preventing effective draining of the low point leading to a wet area.

- New stormwater treatment and management system
- Further investigation to assess condition of underground sanitary piping.
- Assume replacement of sanitary piping due to age of the system, pending further investigation.

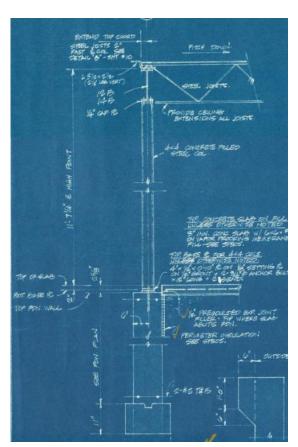
Typical framing wall section

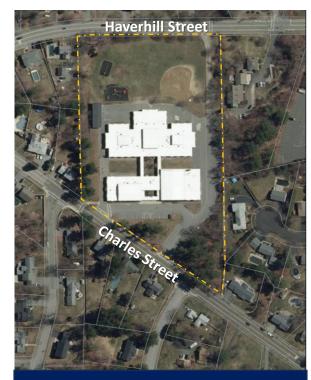
We're looking at ways to improve on-site circulation and accessibility.

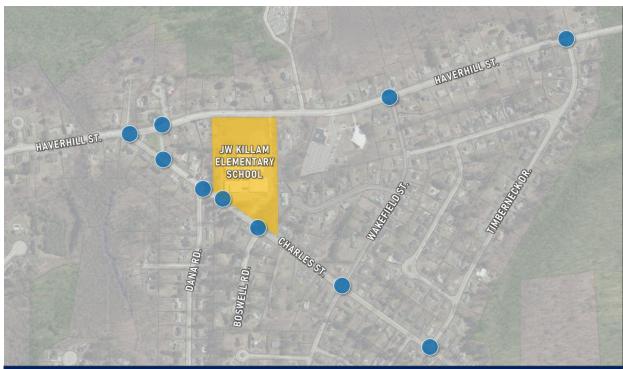
As well as looking at the greater roadway network to improve traffic congestion and multimodal safety/connectivity.

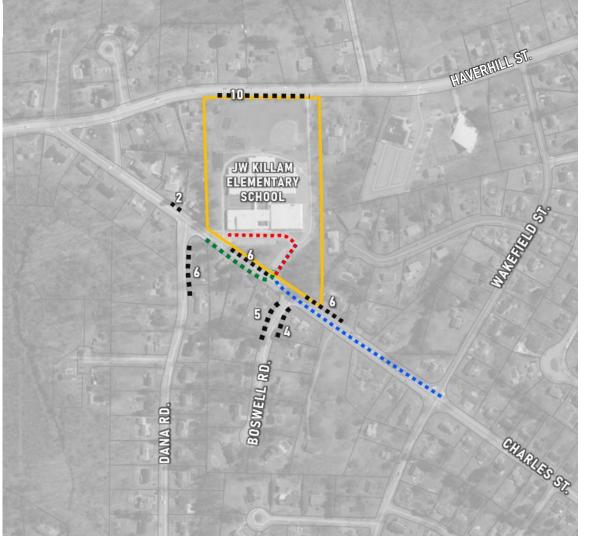
- Frequent crossings result in longer service rates and queue lengths.
- Large turning radii encourages faster turning speeds
- Offset crosswalk limits sight distance

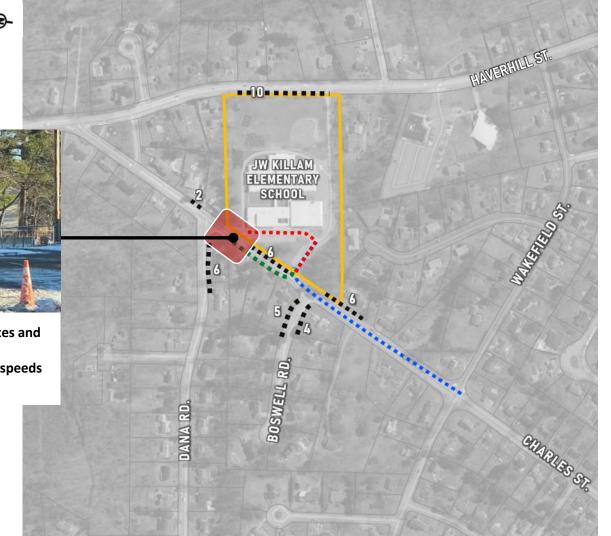
Queued vehicles restrict pedestrians in crosswalk

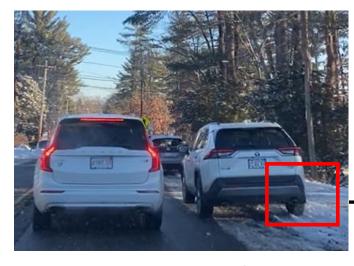
Vehicles parked along eastern side of Charles Street must mount the grass buffer to provide enough room for thru vehicles. This poses concern for pedestrians in sidewalk.

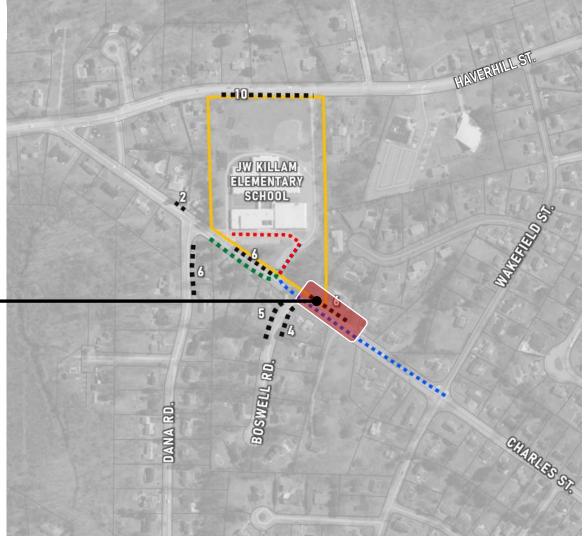
At the height of the arrival period, queues were observed to extend just shy of Wakefield Street. From the back of the queue to the entrance, was a 6:10 rolling queue.

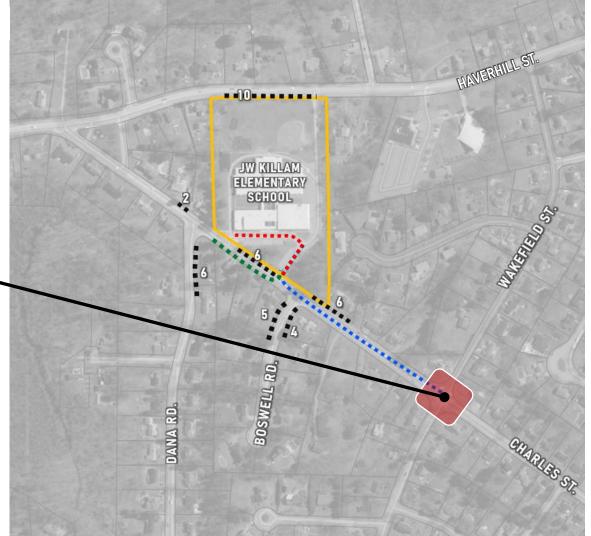
High turnover in on-street parking creates weaving and congestion

Parked vehicles block sight of pedestrians (especially young children) on this busy and high-speed roadway.

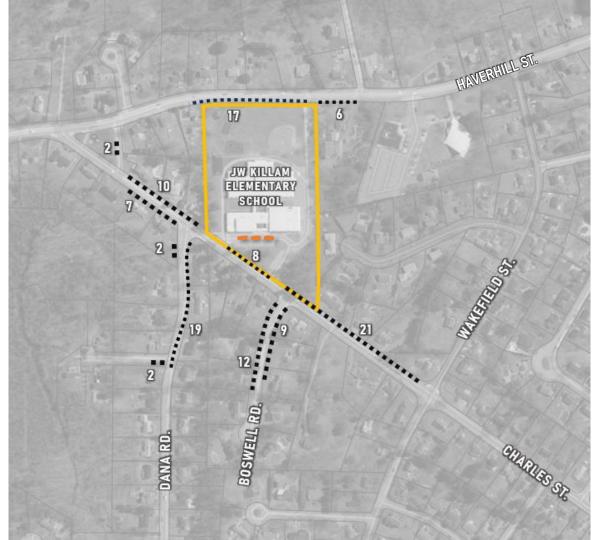
Parking on both sides of Charles Street, Dana Road, and Boswell Road narrows the travel way and creates potential for head-on and sideswipe collisions.

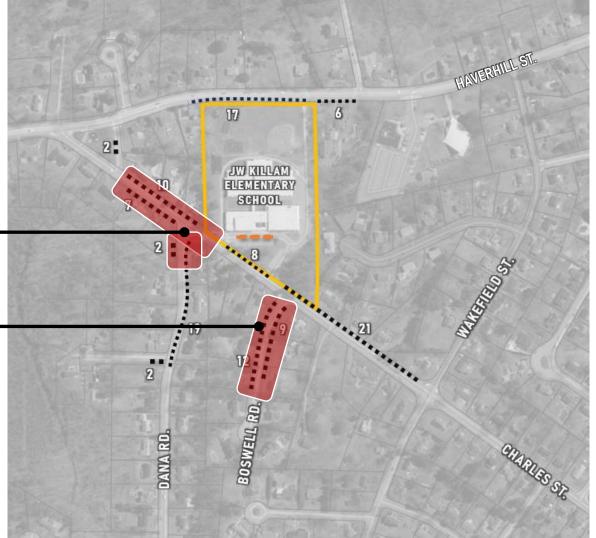
Sight distance issues caused by obstructions and parked vehicles.

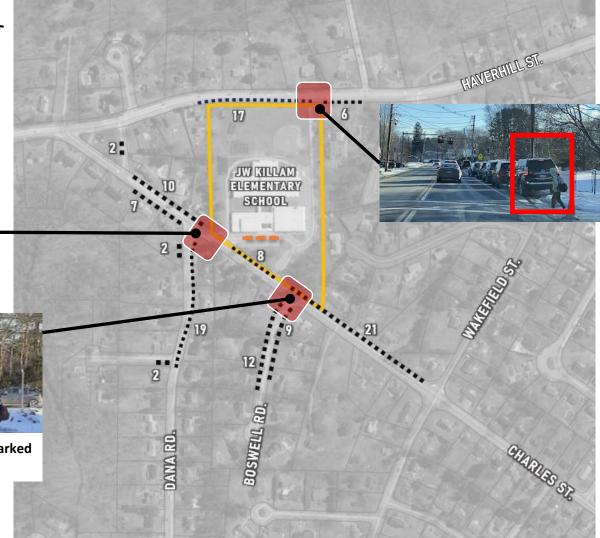
Parked cars extend beyond the provided parking area and jut into the travel way and bike lane.

High turnover in on-street parking creates weaving and congestion

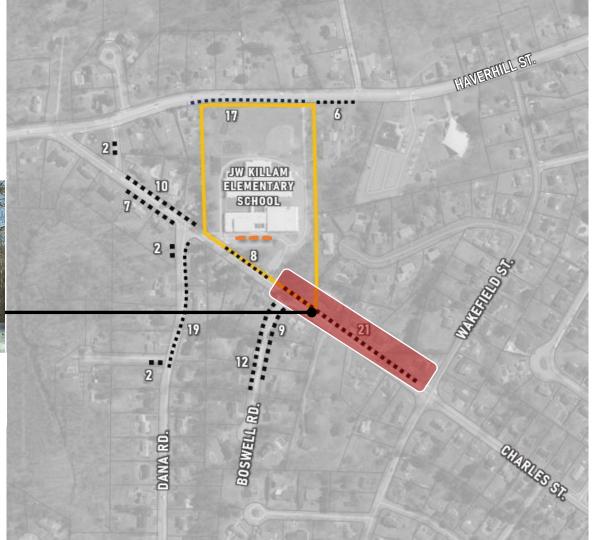
Vehicles observed mounting green buffer and at points were observed within sidewalk resulting in pedestrian safety concerns.

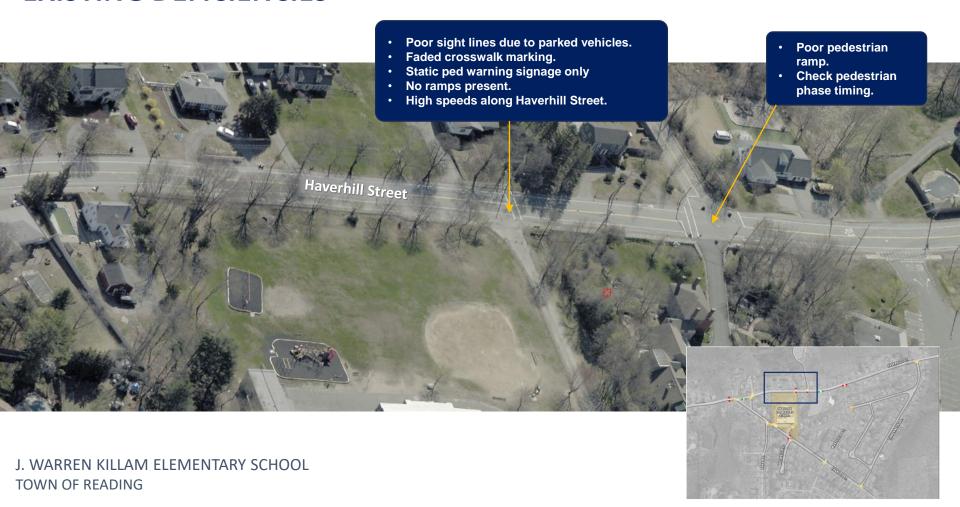
SURROUNDING ROADWAY NETWORK

- · Crossing guard location.
- · Ramps lack detectable warning panels.
- Static ped warning signage provided.
- Poor sight lines from Dana Road and driveway.
- Large radii encourage faster turning speeds out of driveway.

- · Very long crosswalk.
- Large radii encourage high turning speeds out of driveway.
- Ramps lack detectable warning panels.

- Ramps lack detectable warning panels.
- Parked cars block view of peds waiting to cross towards school.

Vehicles observed mounting curb of grass buffer posing safety concerns for students on sidewalks

On- street parking constrains area and restricts emergency vehicle access.

- Very long crosswalk.
- Large radii encourage high turning speeds.
- Ramps lack detectable warning panels.
- Poor sight distance to southeast.

- · Crossing guard location.
- Ramps in poor condition, lack detectable warning panels.
- Static ped warning signage provided.
- Poor sight lines from Boswell Road and Charles Street south due to parked vehicles.

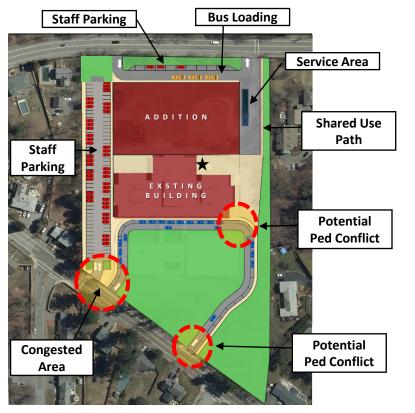
1A. Building Addition – Site Sweep

Staff/Parent Storage	Number of Vehicles
On-Site Staff Parking	110
AM Loading/ Queue Storage	25
PM Parking Storage	30

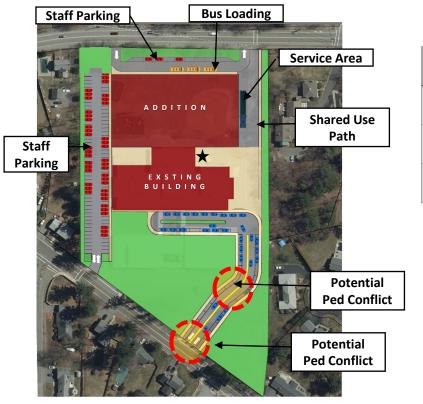
1C. Building Addition – Front Sweep

Staff/Parent Storage	Number of Vehicles
On-Site Staff Parking	110
AM Loading/ Queue Storage	20
PM Parking Storage	40

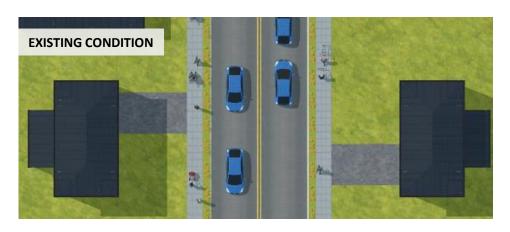
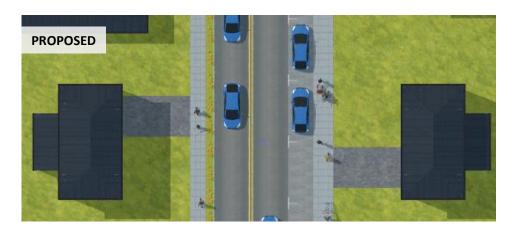
Charles Street Cross Section Reconfiguration

= 30 Marked Parallel Spaces
